Crash Injuries and SUVs: Michigan Case Presentations

Michigan CIREN Cases

Truck into Side of Car

Case Example

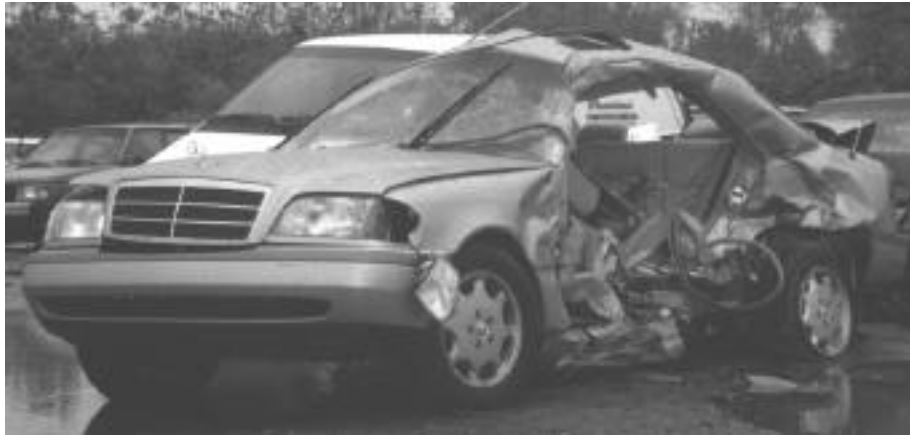
1996 Mercedes C220

CDC: 09-LZAW-4
PDOF: 280 (-80) degrees
DDL: 243 cm
Maximum Crush: 37 cm (estimate)
Crash Severity: 23 mph ΔV

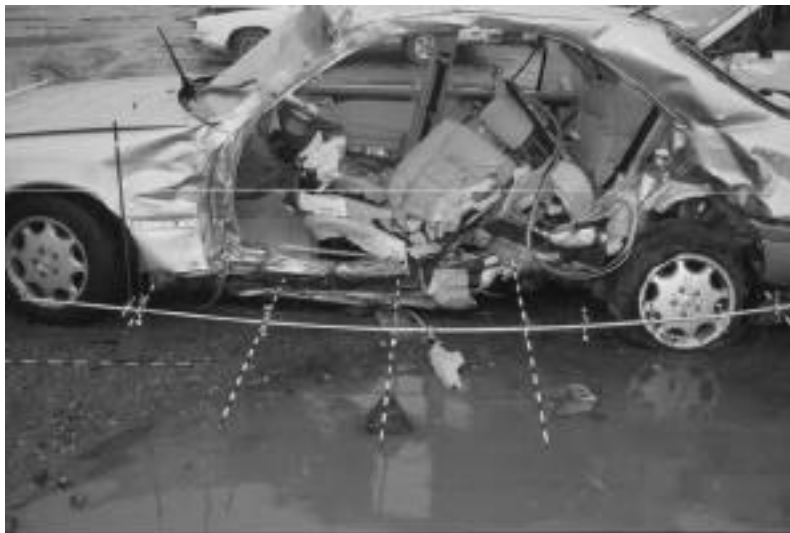
Case Vehicle - 1996 Mercedes C220

Sill was partially engaged - late in the crash event

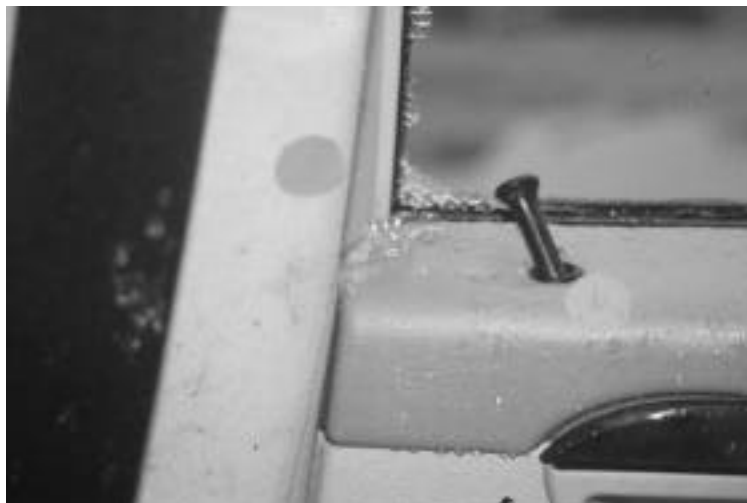
Case Vehicle - 1996 Mercedes C220

Head contact - hair transfer on far-side B-pillar and right-rear door lock

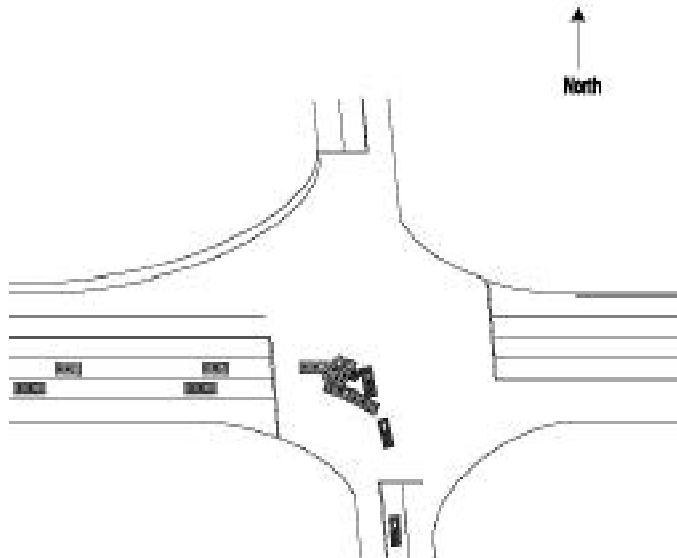
Crash Scenario

- V1 (red) is a 1998 Pontiac Grand Prix (3410 lb)
- V2 (blue) is a 1998 Dodge Durango (4455 lb)
- Driver of V1 made left turn into the path of V2
- Five occupants of case vehicle (V1)
- One occupant in V2
- Dark, but lighted
- Snowy weather
- Wet asphalt roadway

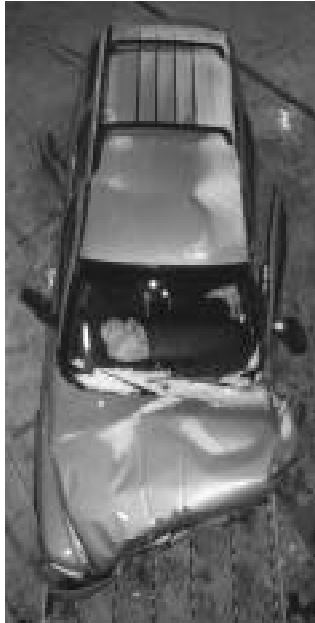
Crush Profile

CDC: 12-FDEW-3

Direct Damage Length = 136 cm

Maximum Crush = 65 cm

81% VOL

PDOF: 10 degrees

23 mph total ΔV

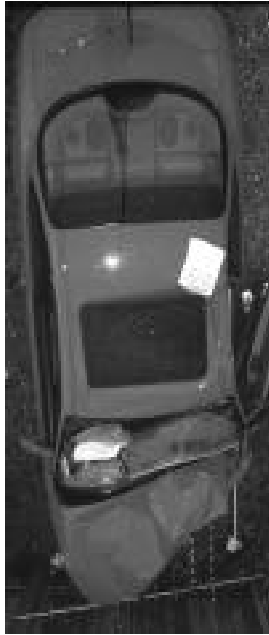
Case Vehicle - 1998 Pontiac Grand Prix
Crush Profile

CDC: 12-FYEW-3

direct damage length = 128 cm

maximum crush = 74 cm

76% VOL

PDOF: 350 (-10) degrees

28 mph total ΔV

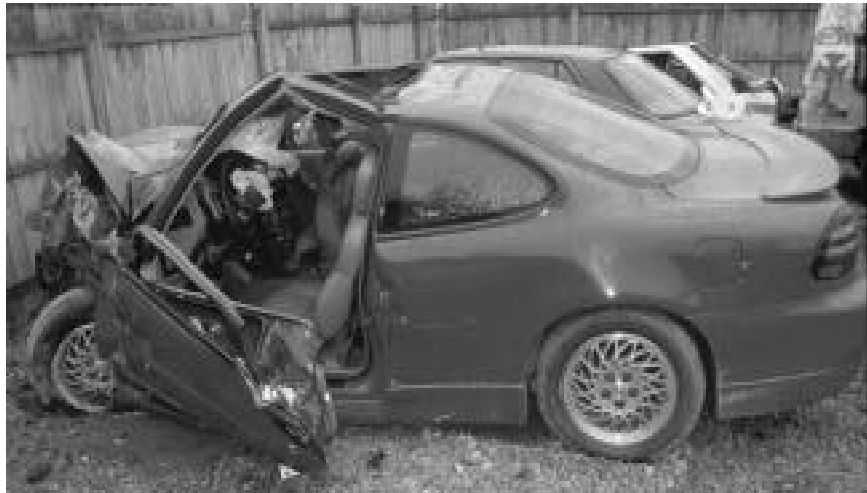
Case Vehicle - 1998 Pontiac Grand Prix
Exterior Damage

Left wheelbase reduced 37 cm

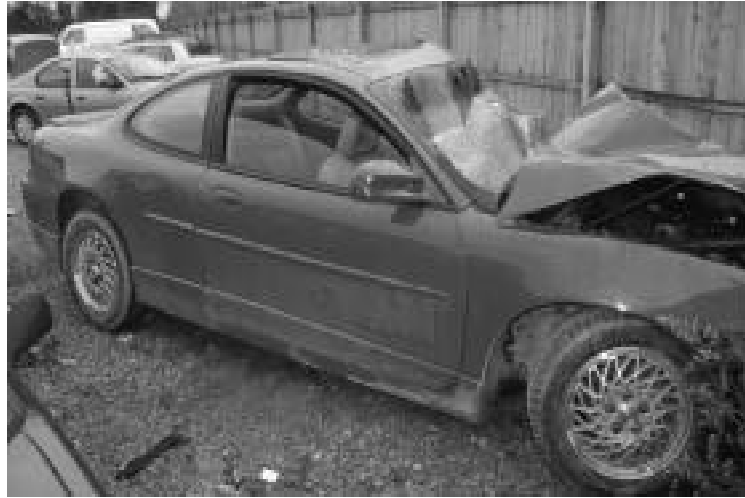
Exterior Damage

Right wheelbase extended 15 cm

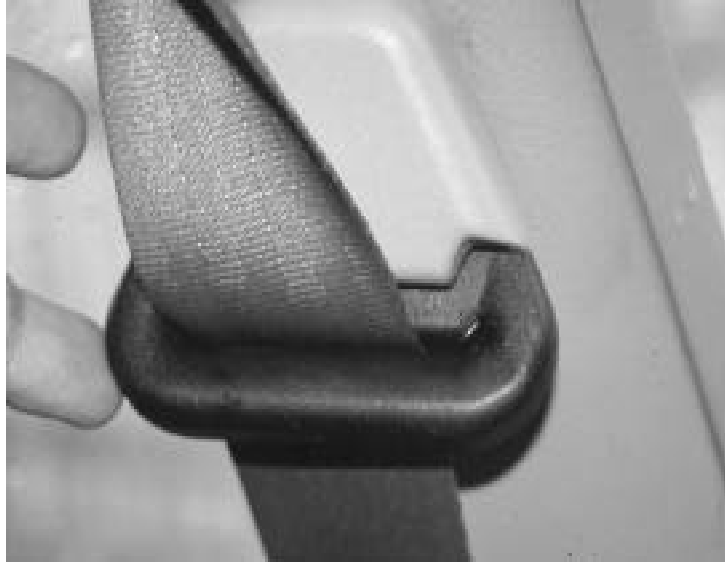
Case Vehicle - 1998 Pontiac Grand Prix
Driver D-ring

No webbing imprint evident

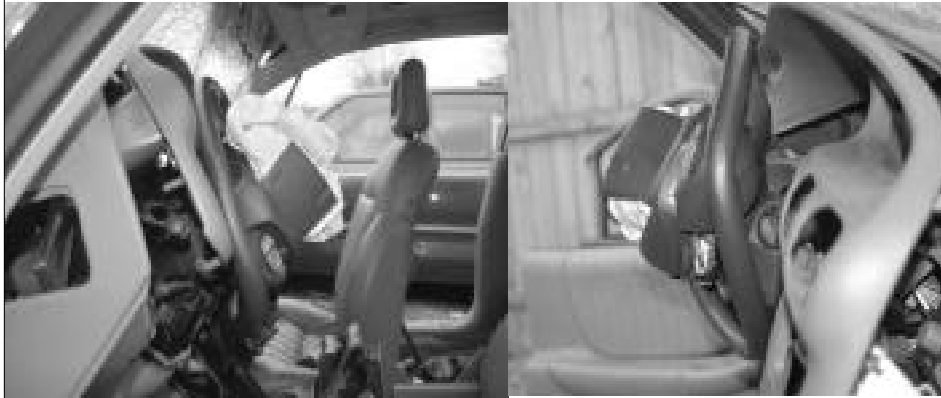
Case Vehicle - 1998 Pontiac Grand Prix
steering-wheel rim deformation - upper half

9 cm of forward deflection

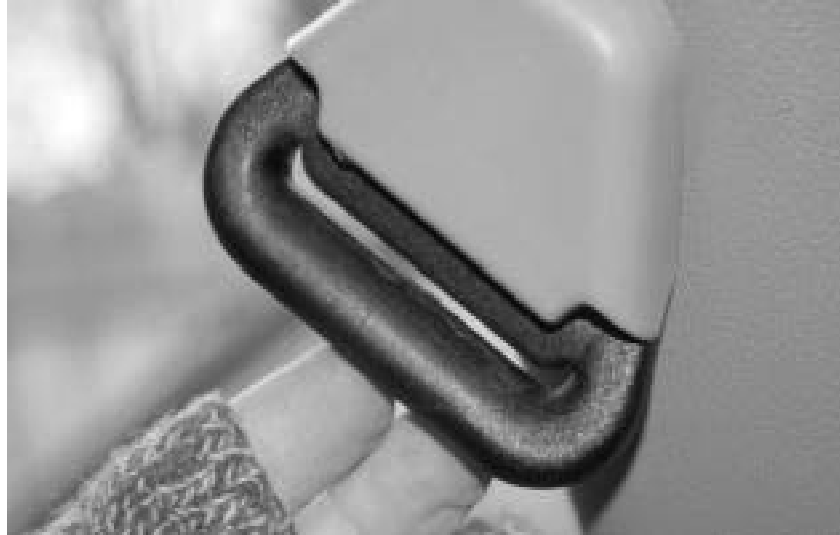
Case Vehicle - 1998 Pontiac Grand Prix
Right-front Passenger D-ring

No webbing imprint evident

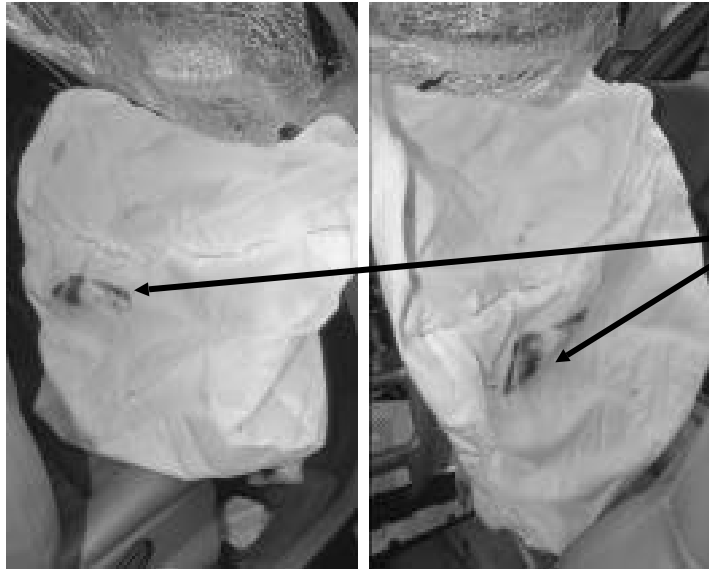
Case Vehicle - 1998 Pontiac Grand Prix
Passenger airbag

Blood

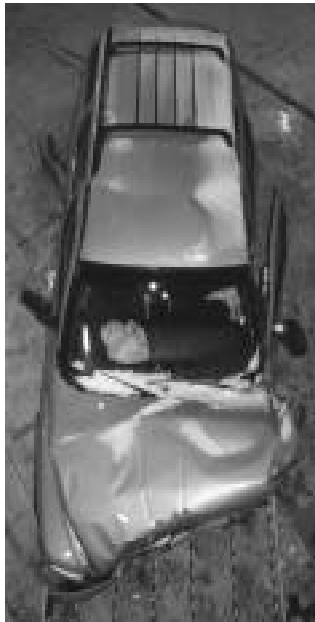
Vehicle 2 - 1998 Dodge Durango

CDC: 12-FDEW-3

Direct Damage Length = 136 cm

Maximum Crush = 65 cm

81% VOL

PDOF: 10 degrees

23 mph total ΔV

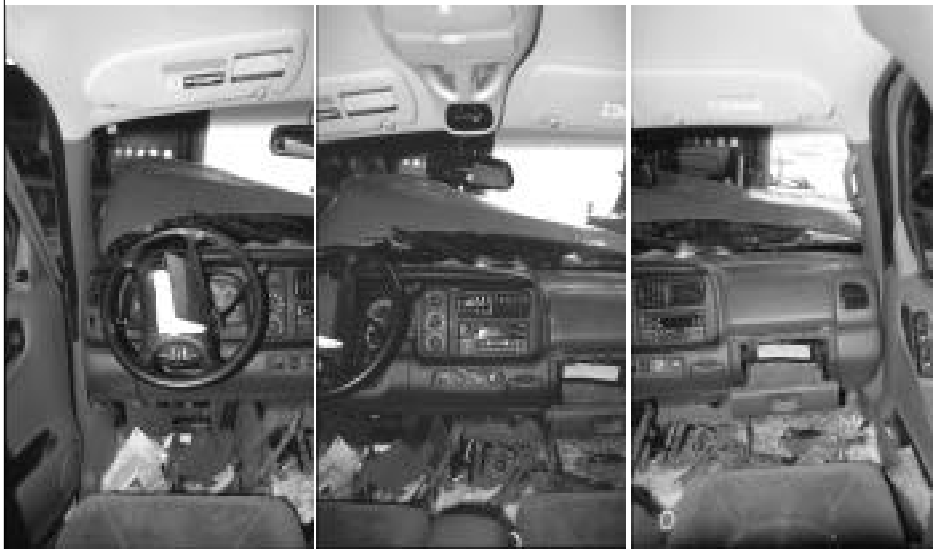
Case Vehicle - 1998 Dodge Durango
1st Row Interior - Overview of IP and Above

Driver toepan sustained 7 cm of rearward intrusion

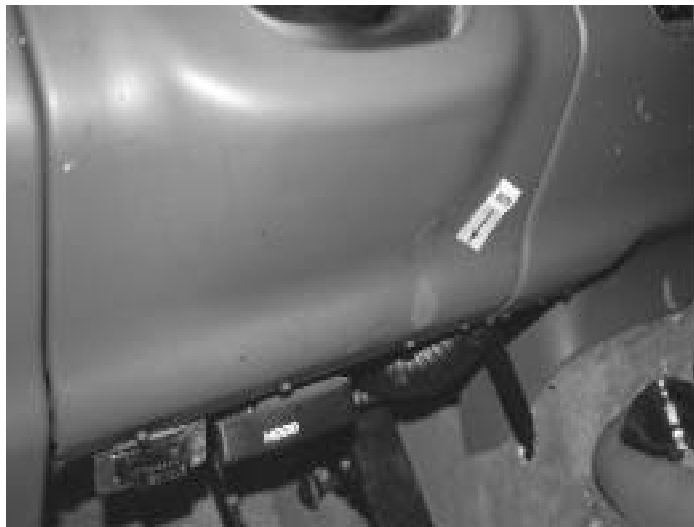
Case Vehicle - 1998 Dodge Durango
Driver Knee Bolster

Right knee strike

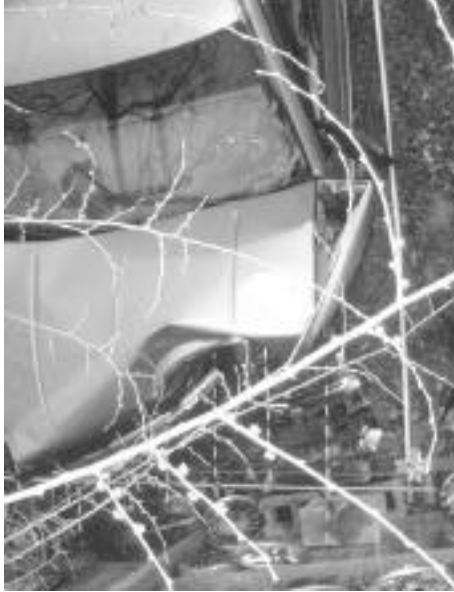
Case Vehicle - 1997 Chevrolet C1500 pickup
Exterior Damage - Overview

- 1st CDC: 11-LFES-1 (sideswipe)
- PDOF = 350 degrees
- 2nd CDC: 12-FYEW-3
- PDOF = 00
- direct damage = 62 cm
- maximum crush = 59 cm
- offset-frontal, 41% VOL
- 36 mph ΔV

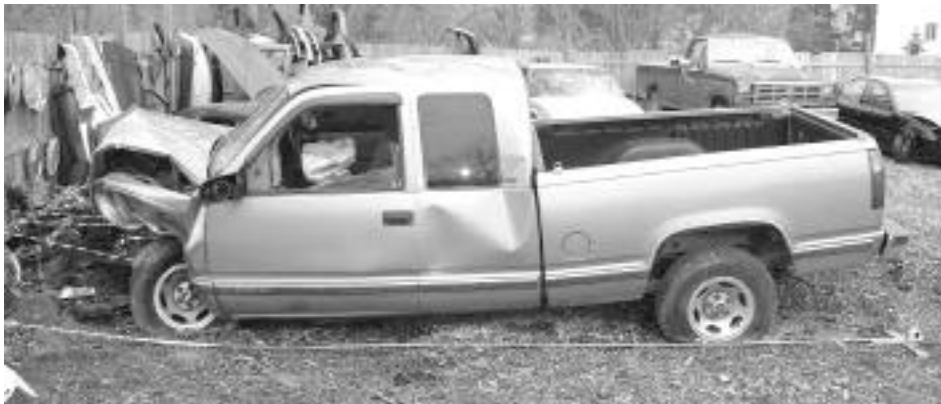
Case Vehicle - 1997 Chevrolet C1500 pickup
Exterior Damage

Left wheelbase reduced 24 cm

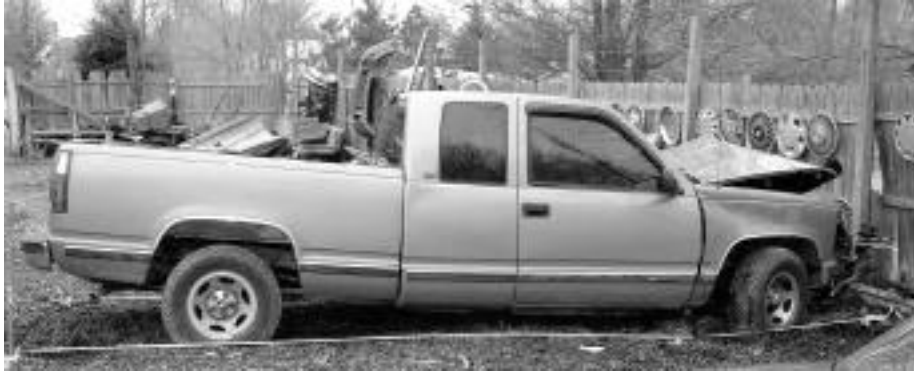
Case Vehicle - 1997 Chevrolet C1500 pickup
Exterior Damage

Right wheelbase increased 7 cm

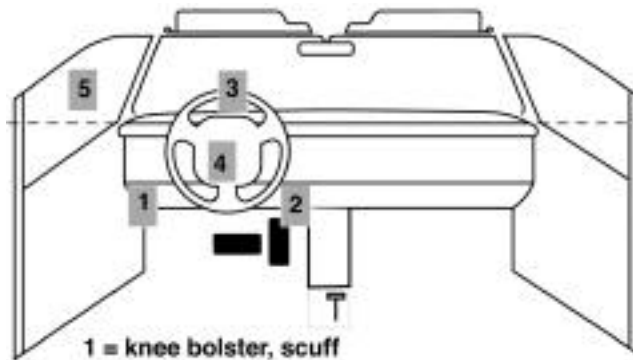
Case Occupant E Possible Driver Contacts

- 1 = knee bolster, scuff
- 2 = utility outlet, cloth transfer
- 3 = SW rim, deformed
- 4 = left airbag flap, cloth transfer
- 5 = left-front window, broken

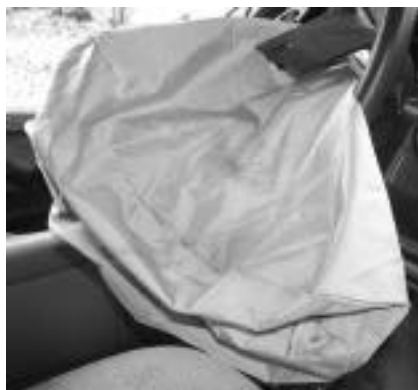
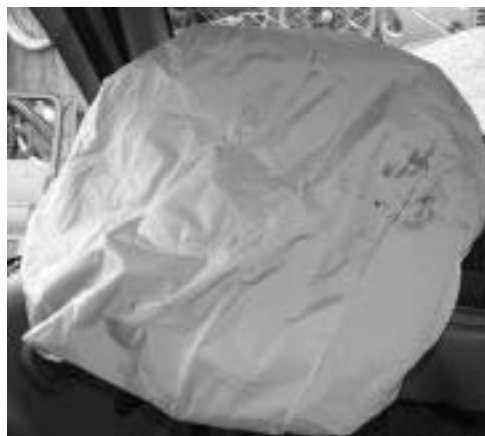
Case Occupant
Driver Airbag with Blood Transfers

Blood stains on lower-right quadrant, both front and rear sides
